Abington Heights School District

District-Wide Facilities Study

February 22, 2023

Abington Heights School District Existing Conditions Reports

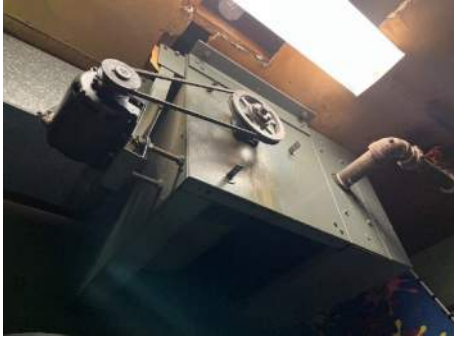
The locker rooms are not utilized. They are served by indoor heating and ventilating units that were not replaced in the 1998 renovation. The systems are antiquated and in poor condition. Exhaust and ductwork systems that were observed are in fair condition. The systems should be replaced in their entirety when the spaces are re-purposed or fully utilized.

Existing Locker Room H&V Unit (pre-1998)

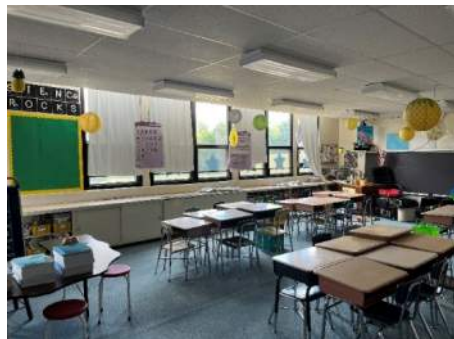
vertical unit ventilators. Air conditioning is not present. The existing transfer air system utilizes the corridor as a plenum which is no longer permissible by International Mechanical Code due to its lack of ability to limit the transfer of smoke or fire through an egress path. Additional systems (indoor air handling units, fan coil units, ceiling-mounted horizontal unit ventilators) are present in support, auxiliary, and interior spaces.

Typical existing Classroom with under-window vertical Unit Ventilator

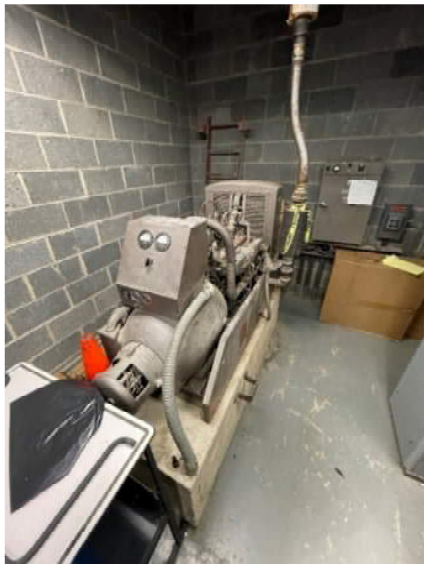
Old abandoned 20KW interior gasoline generator

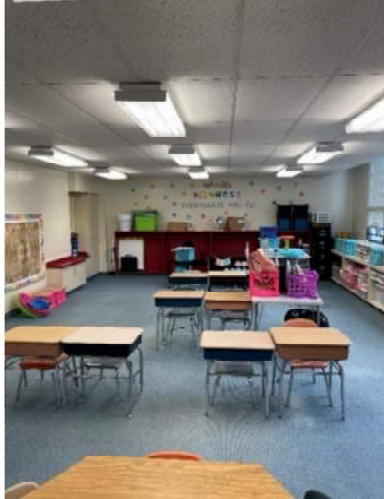
Surface mounted wrap around fixtures

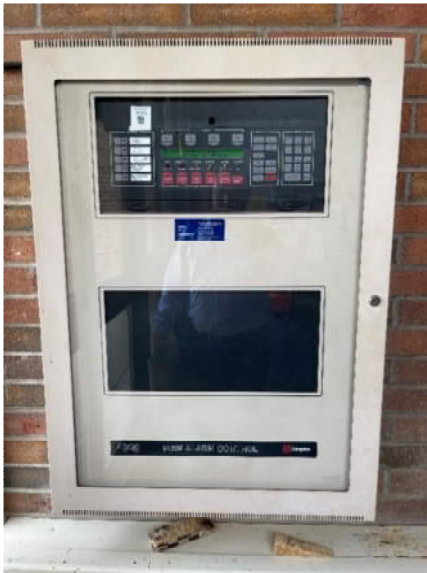
Simplex 4020 fire alarm control panel

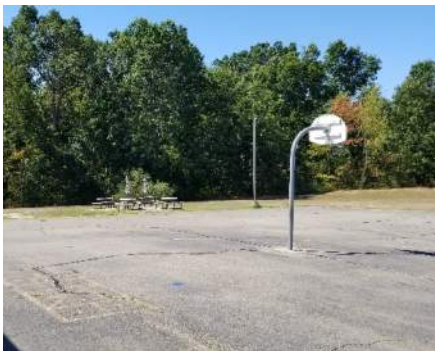
Hard play space in rear of building

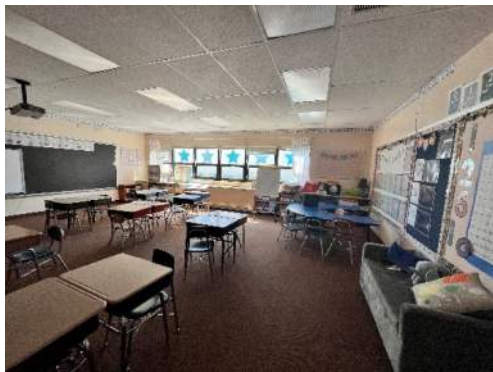
Typical classroom layout

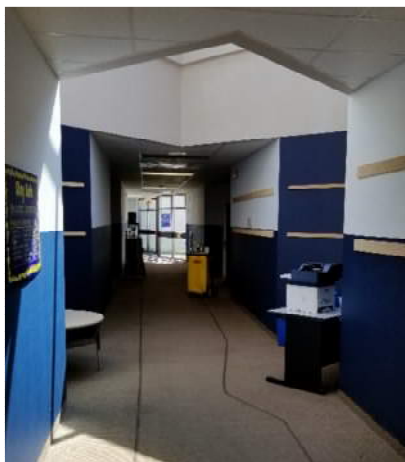
Typical corridor

NRES.BI.04 Replace carpet in corridors with a more durable material like VCT.

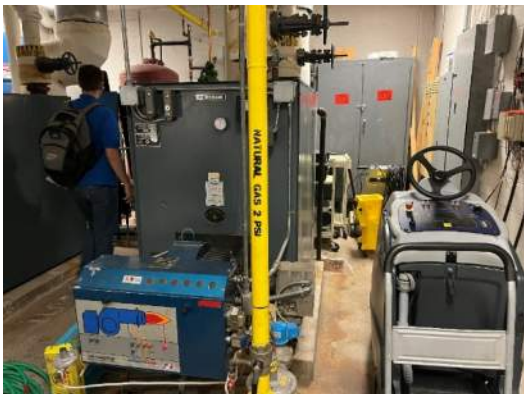
Building hot water is generated by two dual-fuel (natural gas and oil) Weil McClain Series 88 cast iron boilers. The boilers are original to the building and each has a capacity of 1,419 MBH. The boilers are in fair condition but have exceeded their expected life cycles. Each boiler has a PowerFlame dual fuel burner. The District has abandoned the oil system at this building and it is no longer operational as a dual-fuel system. The breeching and accessories associated with the boilers are in poor condition. There are two base mounted distribution pumps that are in poor condition and there are no VFD's associated with the pump motors. The hot water piping, valving, and insulation appear to be in poor condition and as a general statement, the hot water plant is due for a replacement.

Heating System

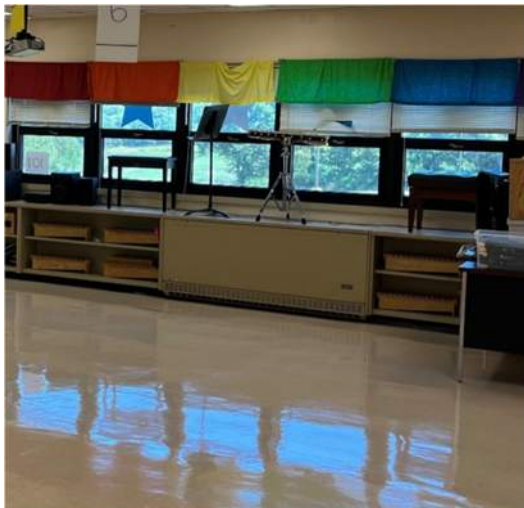
Existing under-window vertical unit ventilator

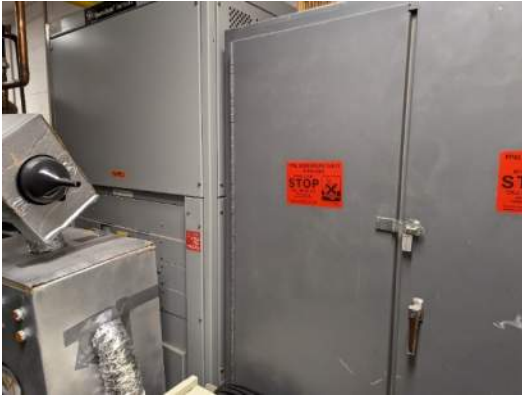
The electrical service originates from a PP&L pole. The electrical service drops underground, from the PP&L pole to an exterior PP&L owned transformer located near the main mechanical room. The transformers feed a CT cabinet and a 1000A 120/208V 3PH 4W distribution panelboard in the main mechanical room. There is storage in front of the distribution panel which is not code compliant. All 208V electrical equipment requires a minimum 3 feet of clearance in front. The distribution panelboard feeds multiple smaller panelboards throughout the building. All distribution equipment observed was manufacturer by GE with an install date of 1995. The gear is in good condition.

Main Distribution Panel with storage in front

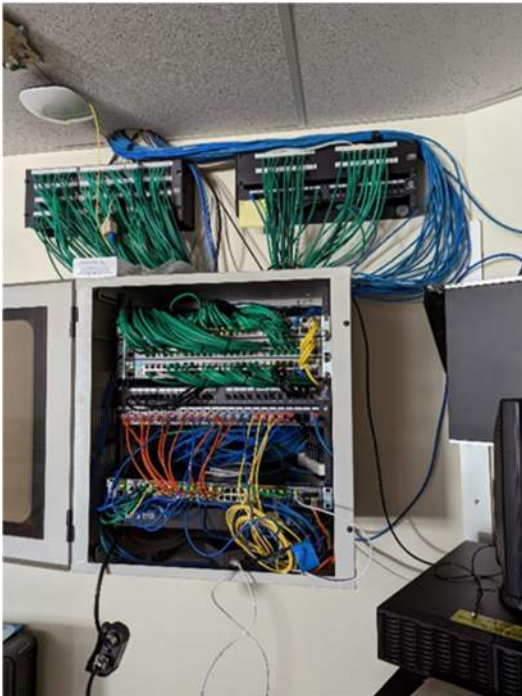
Typical Data Rack

It is recommended that additional wireless access points and additional data drops should be considered for future upgrades. The CATV system and all abandoned cables should be removed if it is no longer in use.

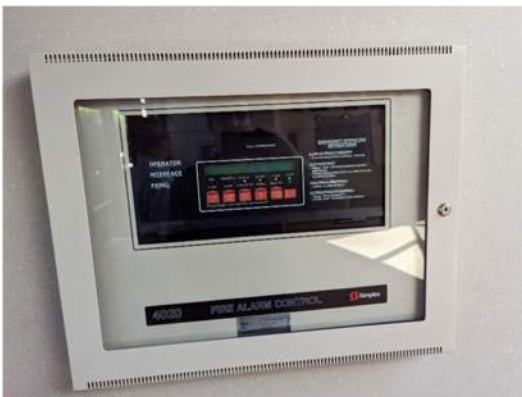
The existing fire alarm system is a Simplex 4020 system. Smoke detection and notification devices are provided throughout the building. The system is in fair condition, however current code requires voice notification, and the existing system utilizes horns/tome notification. Significant renovations or modifications to this system will require the systems be upgraded to the current code.

Simplex 4020 fire alarm control panel

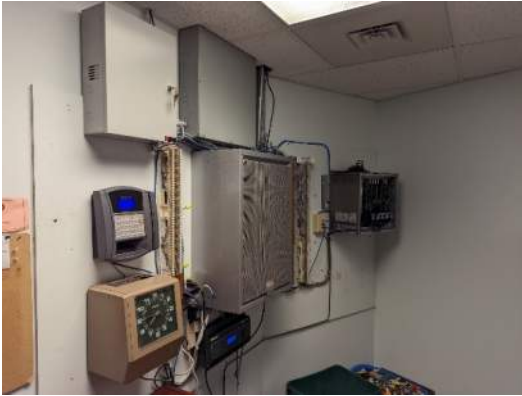
Clock/speaker units and ceiling mounted speakers were observed throughout the building. The clocks are National Time and headend clock control is Dukane. The existing intercom system utilizes a Dukane head end and appears to be in adequate condition. System appears to have been installed in 1995. The existing phone system is a VOIP system and appears to be in adequate condition.

Existing wall mounted PA rack

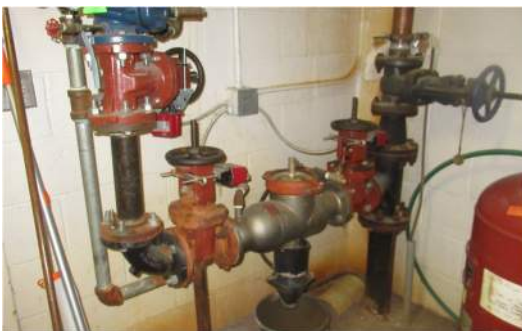
Existing Fire Protection/
Domestic Water Service Entrance

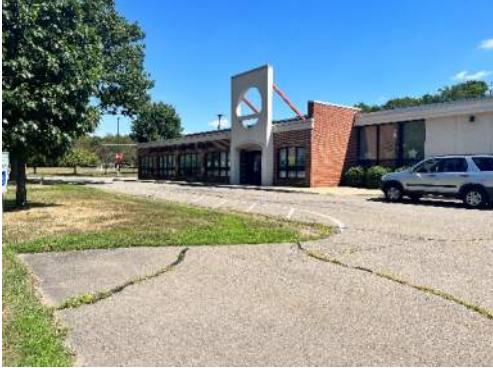
Cracking in parking area

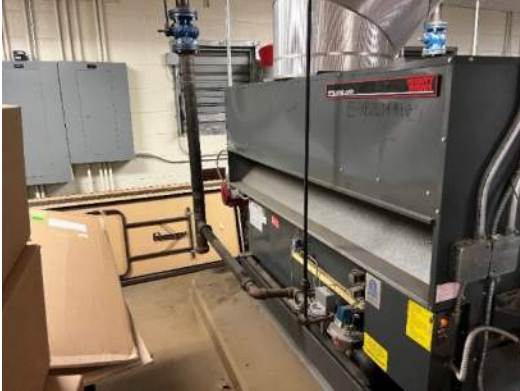
Existing Lars Teledyne cast-iron natural gas boiler

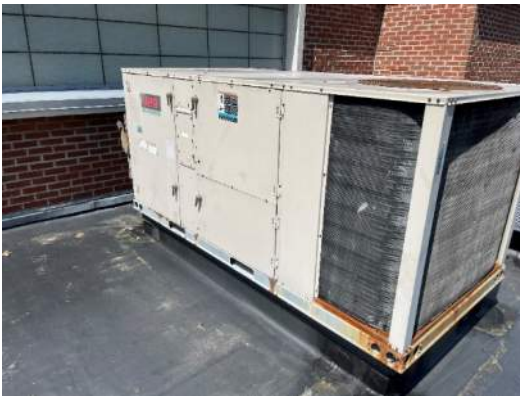
Existing packaged rooftop unit (DX cooling & gas furnace)

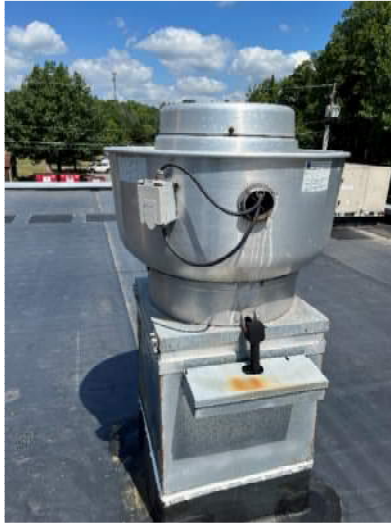
Existing Kitchen hood exhaust fan (EF-5)

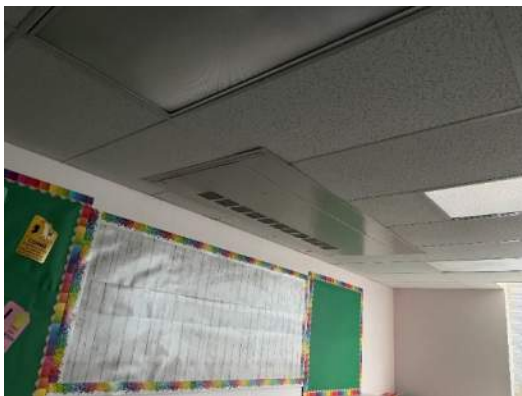
Existing ceiling-mounted horizontal unit ventilator

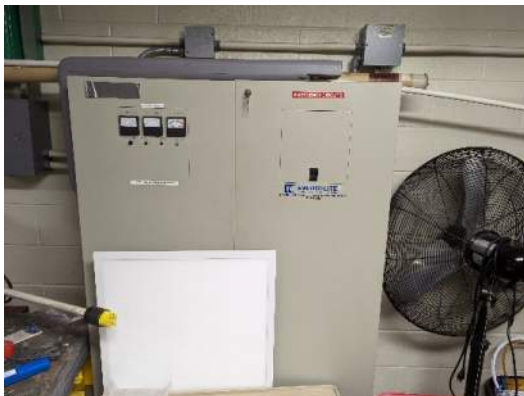
There is no emergency generator system. All emergency lighting is supplied via emergency battery packs, remote heads, and a central inverter system. There are only single remote heads above egress doors on the exterior, current code requires redundancy. The inverter is near end of life and should be replaced.

Central Inverter System

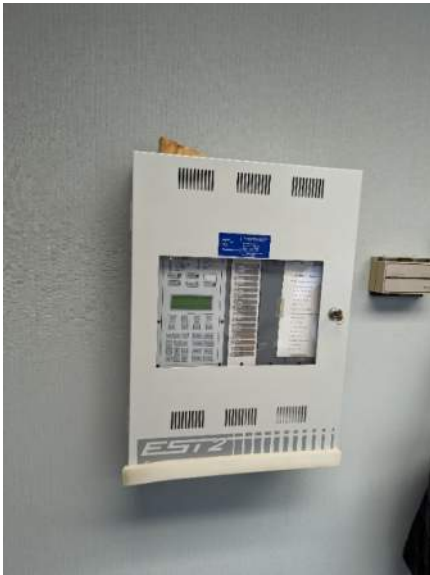
Edwards EST2 fire alarm control panel

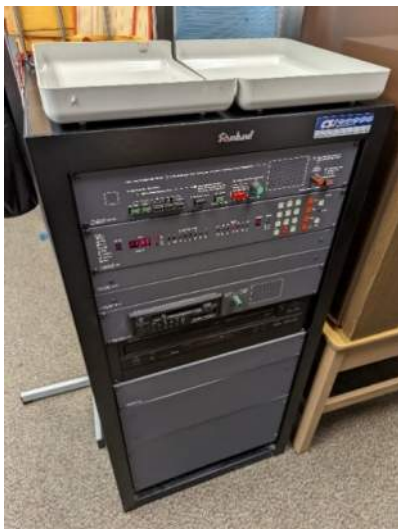
Clock/speaker units and ceiling mounted speakers were observed throughout the building. The clocks are National Time. The existing intercom system utilizes a Rauland head end and appears to be in adequate condition. System appears to have been installed in the last major renovation. The existing phone system is a VOIP system and appears to be in adequate condition.

Existing PA rack

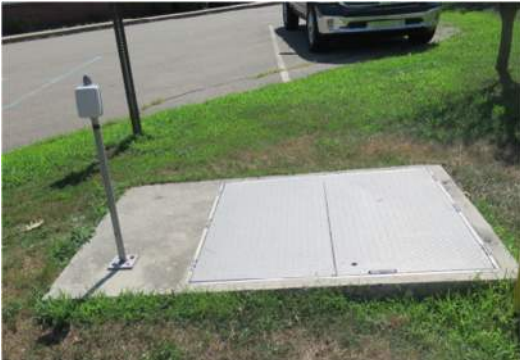
Existing Domestic Water Service Meter Vault

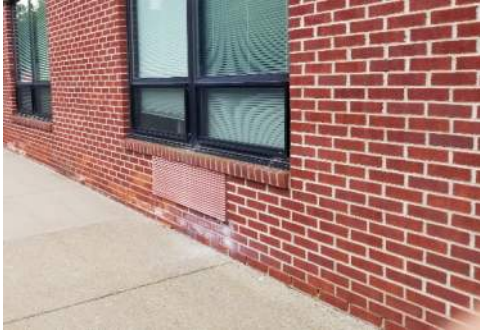
Exterior brick with some efflorescence at openings

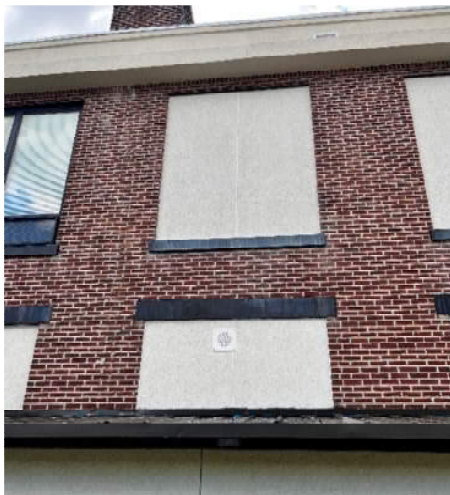
Discoloration at heads and sills

WES.BX.03 Repair or repaint heads and sills of windows.

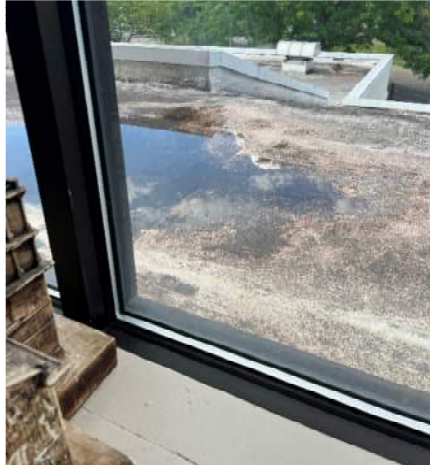
Ponding on toilet room additions

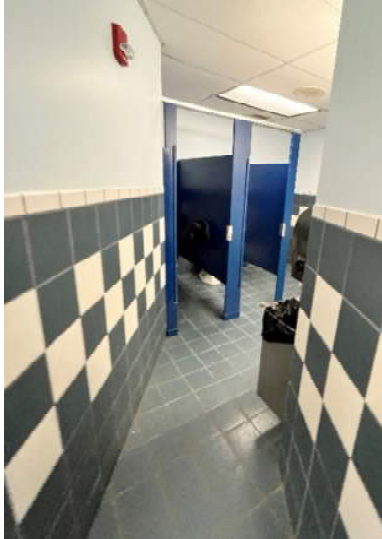
Narrow entry to gang toilet rooms

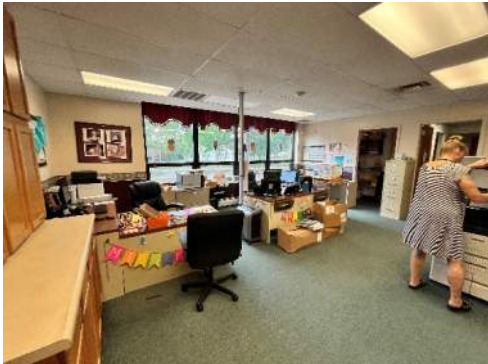
The entry vestibule into the school is disconnected from the main office. The vestibule is also not visible from the front desk which presents a security concern. Once a visitor is let into the building, they have access to the entire school.

Main office for administration

- WES.BI.04 Consider connecting vestibule and reconfiguring administration suite to integrate a secure entry protocol into the building. Replace all sinks in classrooms to provide ADA compliance.
- WES.BI.05 Reconstruct toilet room for nurse's suite.

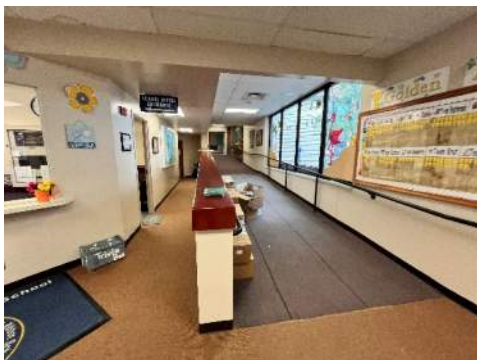
Ramp connection to original wing of building

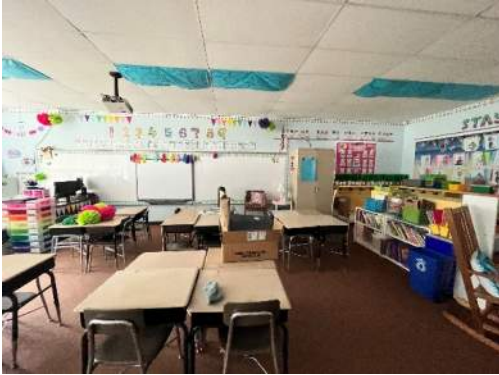
Typical classroom

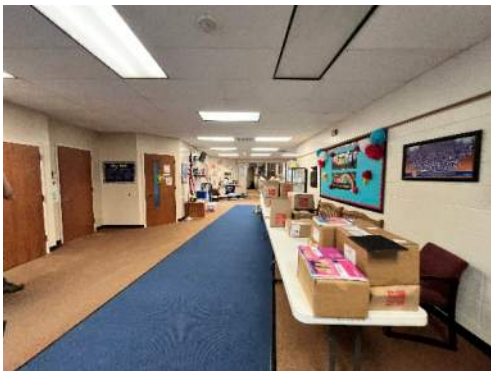
Corridors have carpet, painted walls, and acoustical ceiling tile (ACT) throughout. In the original building, there is interior brick wainscoting on the walls. This is in good condition. All other ceilings and walls are in fair condition. The carpet in the original building has been replaced and is in good condition. The carpet in all other areas of the school is in poor condition.

Typical corridor

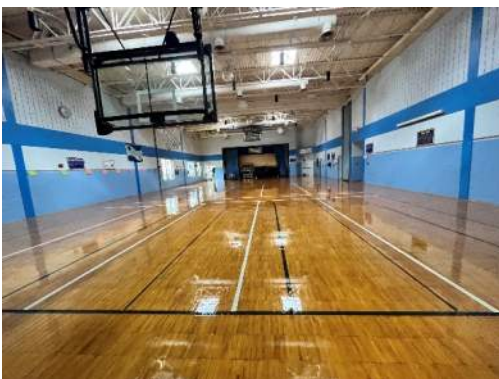
The multi-purpose room has wood flooring, painted CMU walls, and an open ceiling. The kitchen for serving is adjacent. The stage pulls out of the recessed area when needed. The finishes are in good condition.

Multi-purpose room

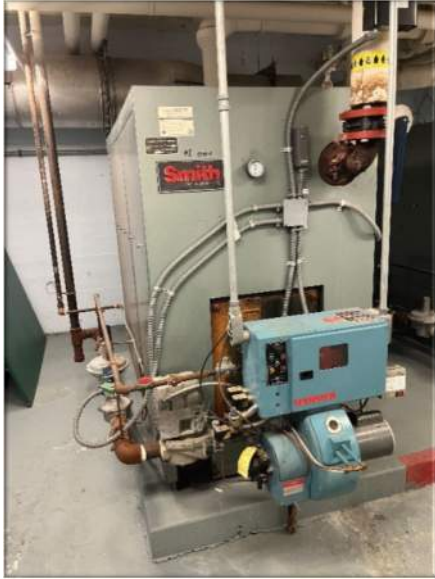
Existing H.B. Smith cast-iron natural gas boiler with Webster burner

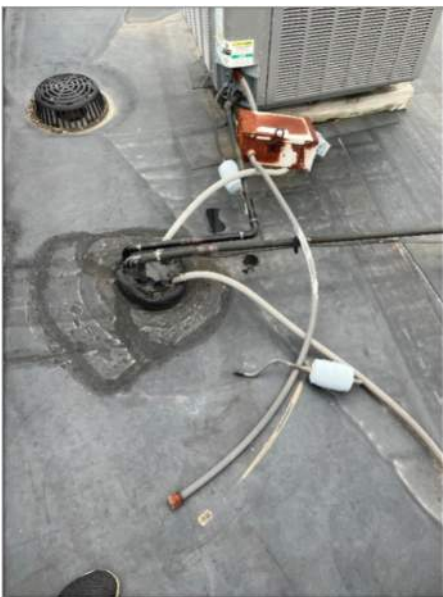
Existing pipe portal and electrical disconnect for the Library Condensing Unit

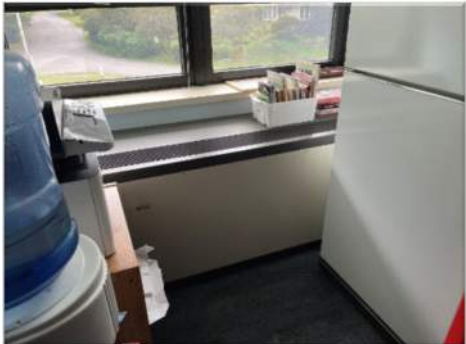
Existing under-window unit ventilator

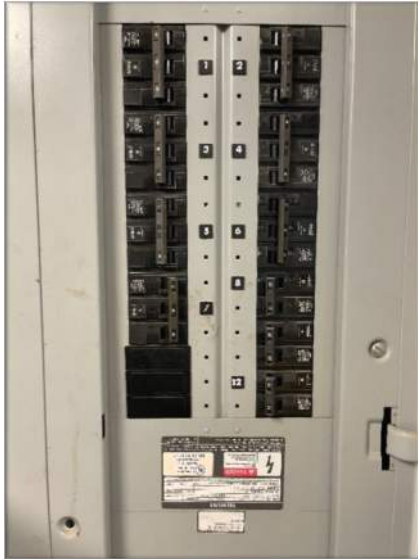
Typical Siemens 1995 branch distribution panelboard

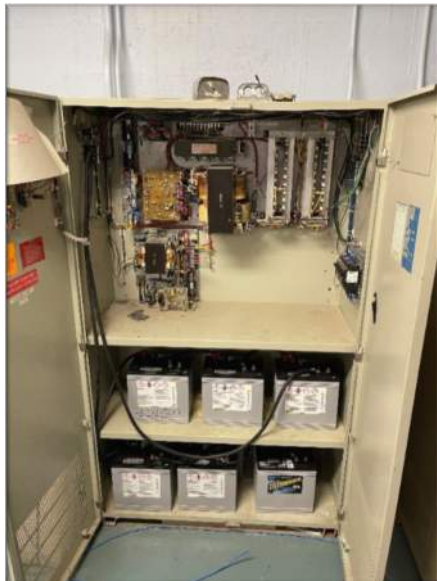
Emergi-Lite inverter for emergency lighting

It is recommended that the existing Emergi-Lite inverters be removed and a new generator, two automatic transfer switches, one manual transfer switch, and a temporary generator hookup is installed. Two automatic transfer switches are required to separate life safety lighting loads from other non-life safety loads. A manual transfer switch and temporary generator hookup is code required to hookup a portable generator to bypass the permanent generator for maintenance purposes.

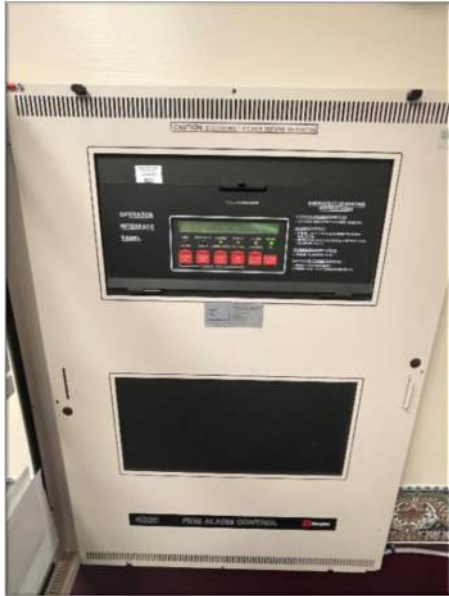
Simplex 4020 fire alarm control panel

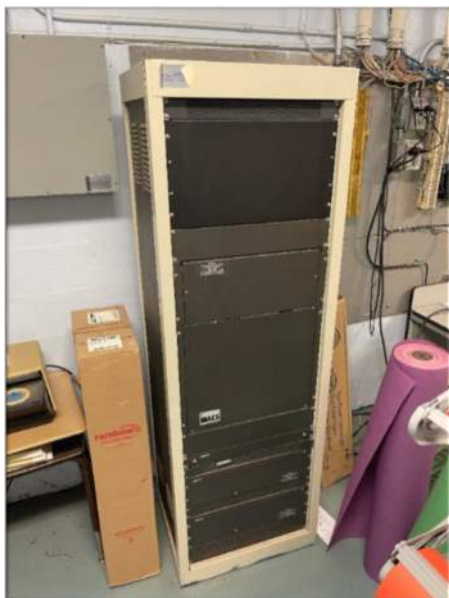
Original wall mounted clock/speaker units were observed throughout the building. The clocks are National Time and headend clock control is Dukane. The existing intercom system utilizes a Dukane head end and appears to be in adequate condition. The existing phone system is a Mitel Voice Over IP (VOIP) and appears to be in adequate condition. It is recommended that the existing public address system be upgraded to an I.P. intercom system. PA system will be approaching end of life soon and shall be replaced in 3-5 years. It is recommended that the master clock system be replaced as it is nearing end of life.

Existing Dukane floor mounted PA rack

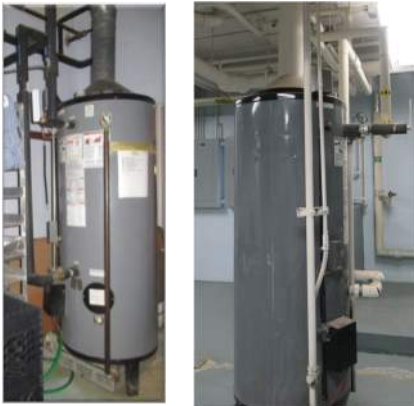
The existing domestic water heating system serving the kitchen is located in a storage room adjacent to the Kitchen and includes a Rheem 86 gal, 250 MBH gas fired storage type water heater, and hot water recirculation. The installation date of the water heater could not be determined but the water heater appeared to be in fair/good condition.

Existing kitchen (left) and main building domestic water heaters

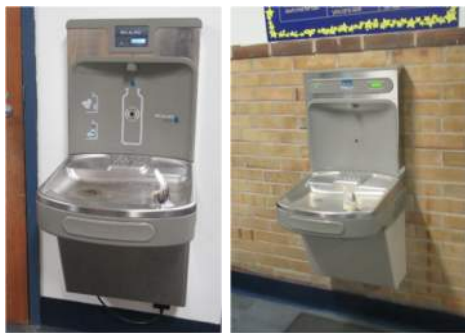
Existing Electric Water Coolers

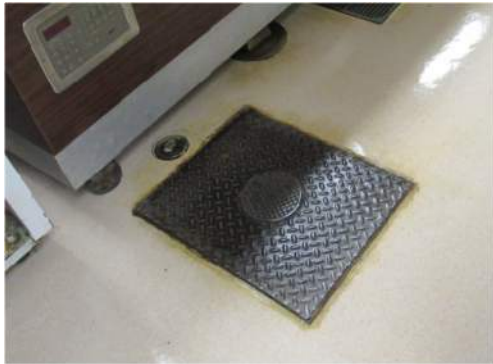
Existing Grease Traps

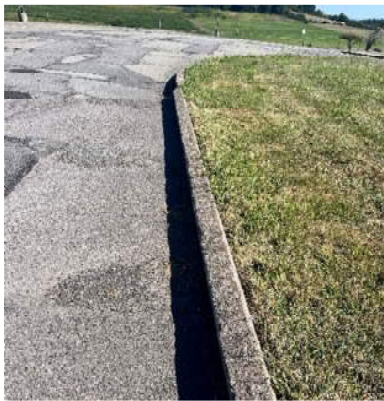
Failing curbs at drives

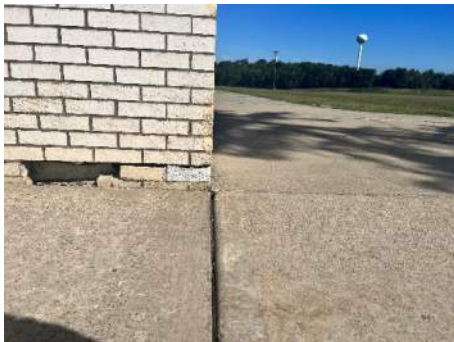
Missing brick, exposing board insulation beyond

Repair/rebuild areas of water infiltration causing spalling to have proper weep holes.

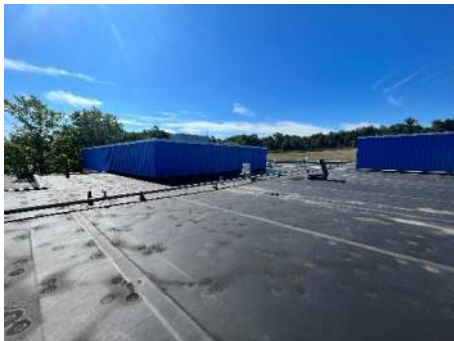
Single-ply roof membrane

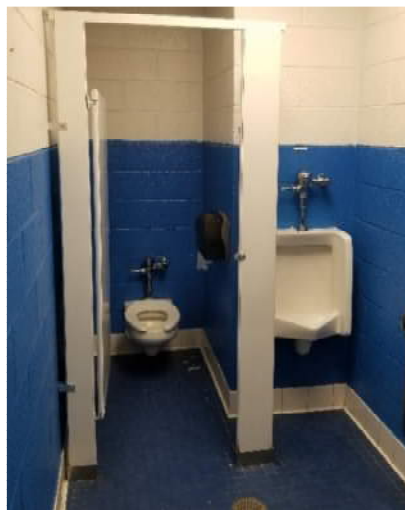
Non-compliant restroom

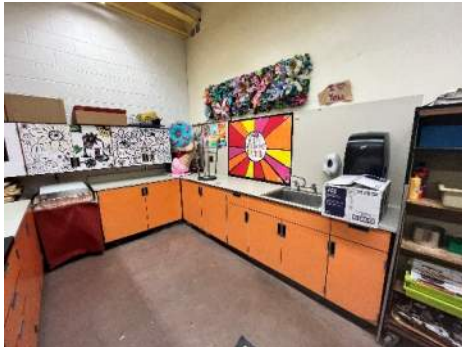
Non-compliant classroom sink in casework

AHMS.BI.03 Replace sinks so at least one in every room where a fixture is located meets ADA compliance.

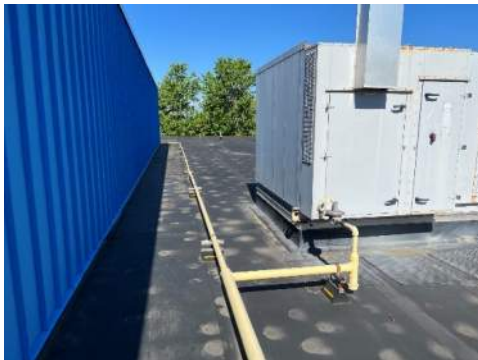
Natural gas piping across roof to packaged rooftop air handling unit

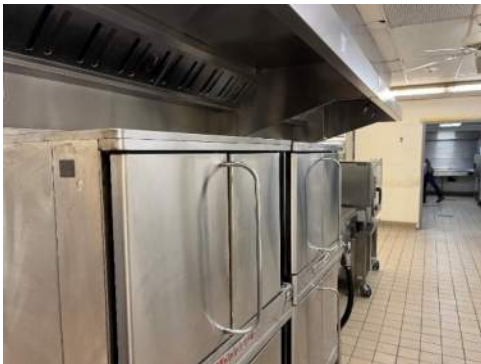
Kitchen grease hood with limited ANSUL system coverage

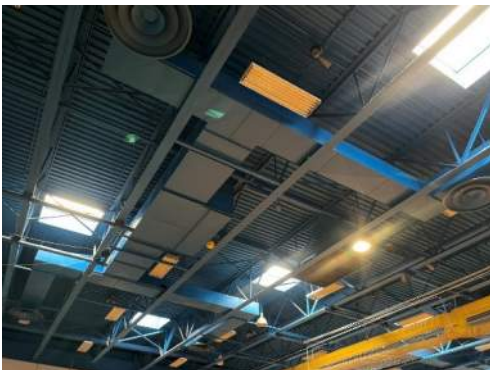
Exposed ductwork systems in the main Gymnasium

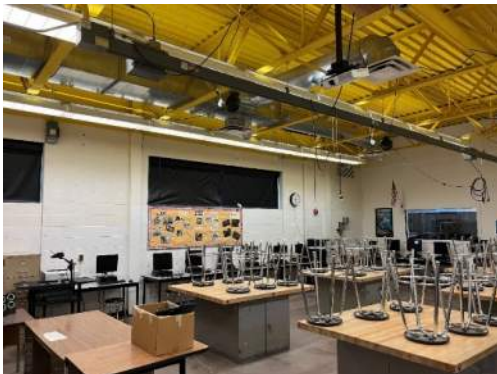
STEM Room with exposed ductwork
(Typical for Tech-Ed Wing)

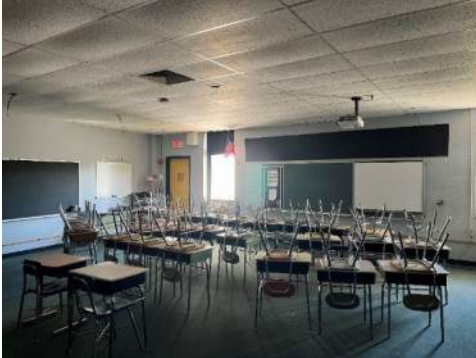
Pod classroom with single supply air diffuser.

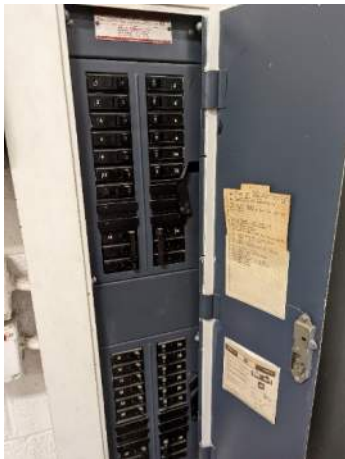
Typical branch distribution panelboard

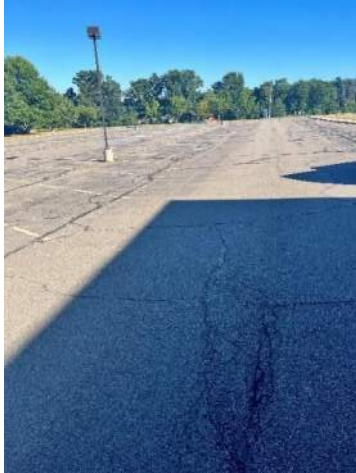
Cracking in staff parking lot

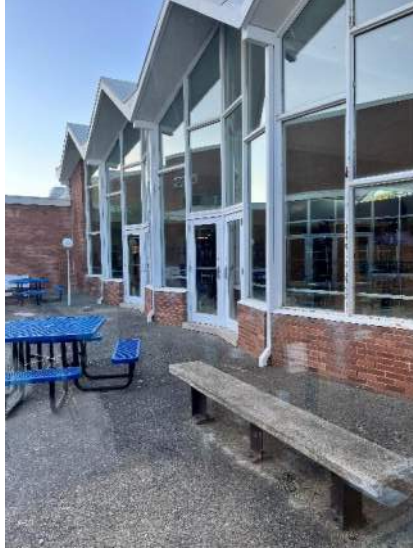
Courtyard outside of cafeteria

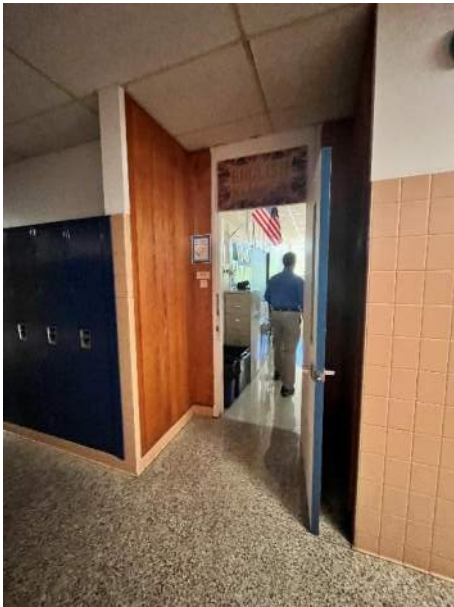
Classroom entry without compliant door clearance

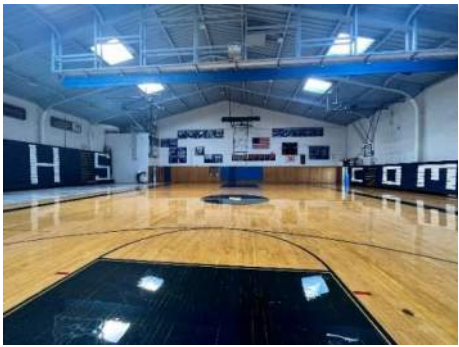
Main Gymnasium

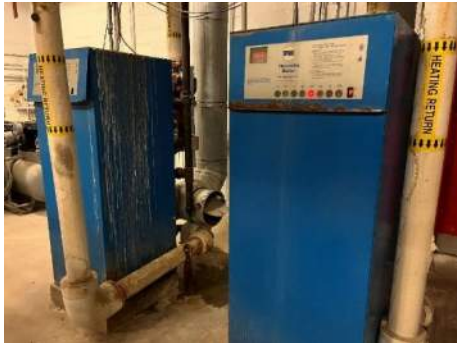
Existing Patterson-Kelley
"Boiler Room" Boilers

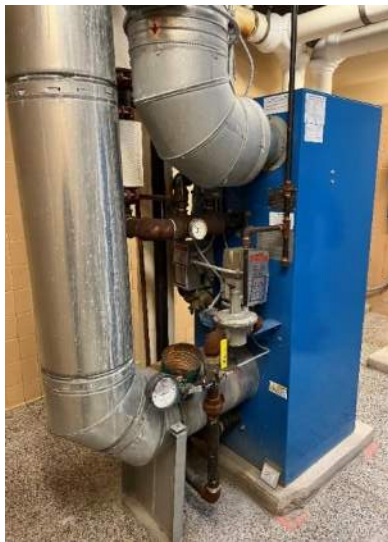
Existing Patterson-Kelley
"Toilet Room" Boilers

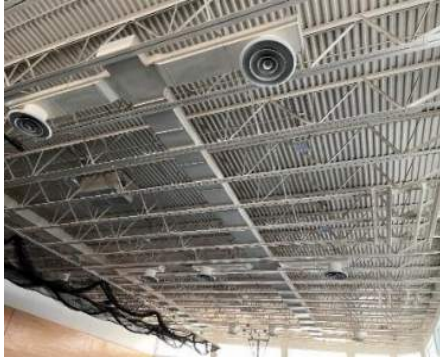
Auxiliary gymnasium supply air ductwork distribution

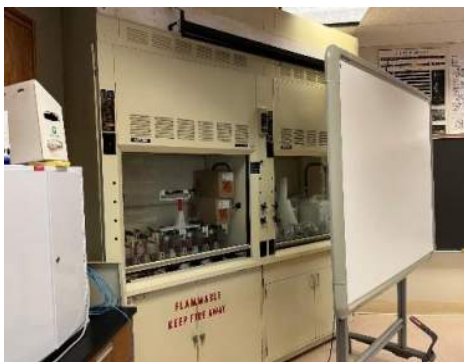
Science classroom fume hood

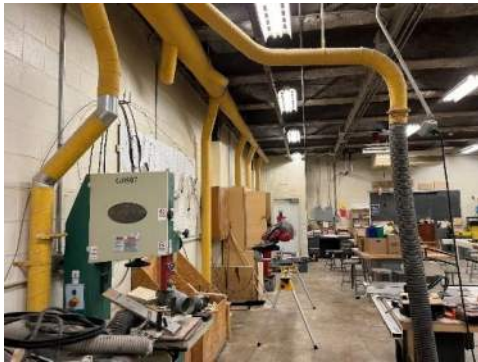
Technical education lab with dust collector array

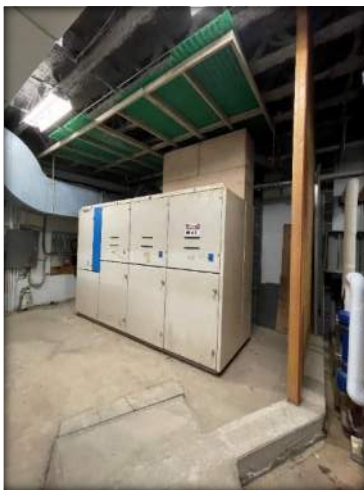
Existing medium voltage switchgear

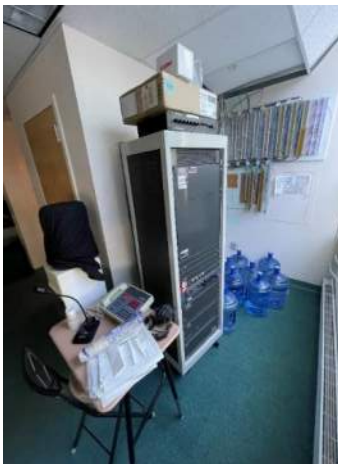
Existing PA rack on wheels

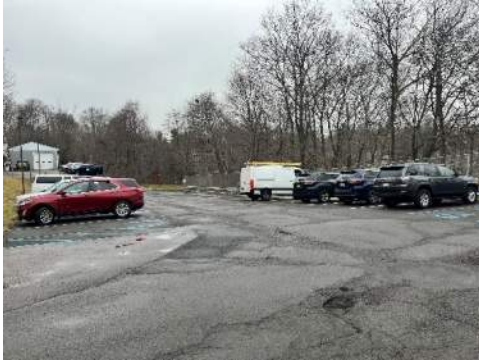
Cracked paving at front entry

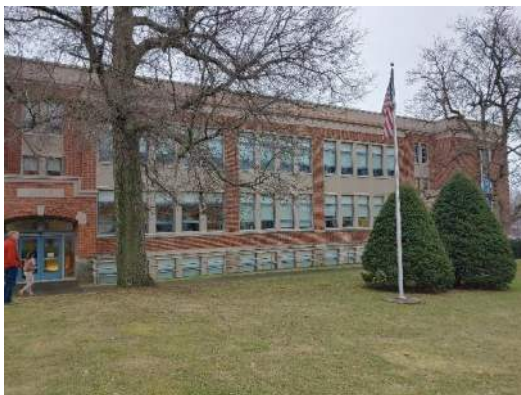
Building facade

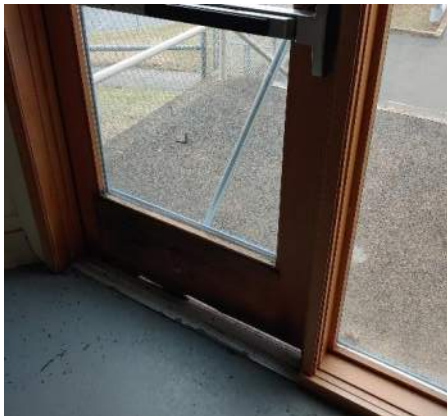
Rotting door bottom

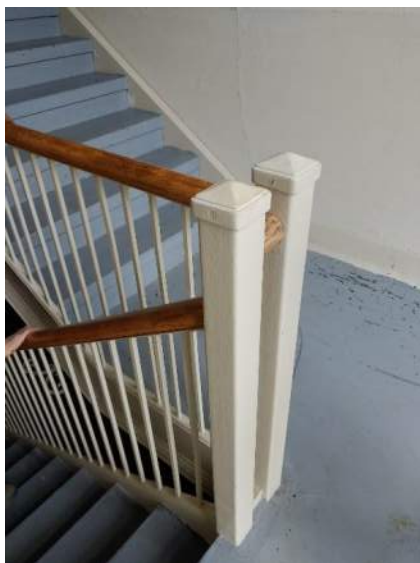
Guardrail that is too low; missing handrail
