Abington Heights School District

District-Wide Facilities Study

February 22, 2023

Abington Heights School District Existing Conditions Reports

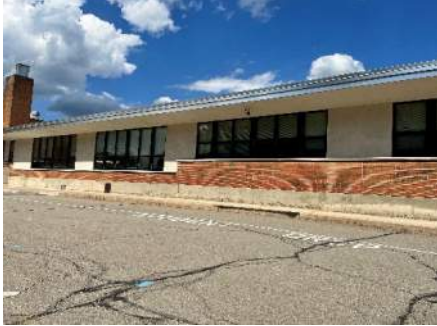
Cracks and damage at drives/parking

There is cracking on the asphalt at almost all locations.

CSES.S.02 Mill and overlay asphalt within five years.

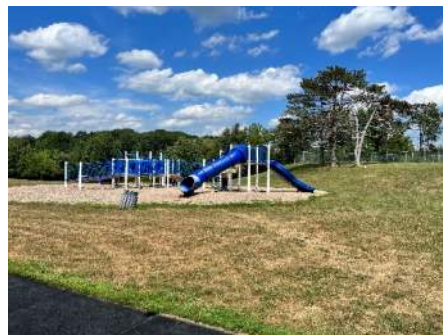
Play area and equipment

The play equipment is in good condition. The play area is not ADA accessible from the building. The surface is wood mulch.

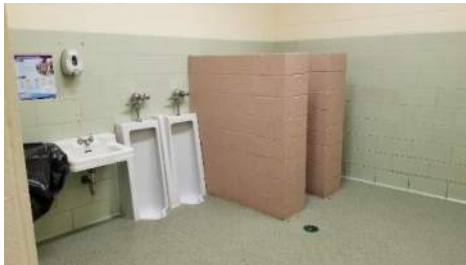
Non-compliant toilet room in locker area

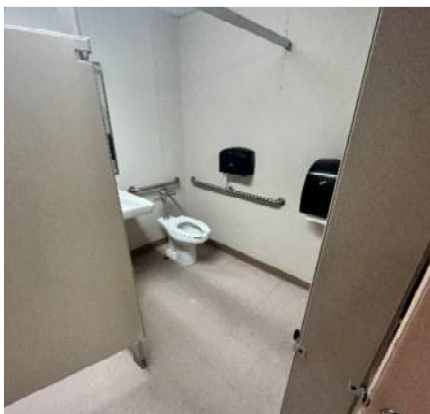
“Handicap Stall” does not meet current ADA code requirements due to fixture clearance

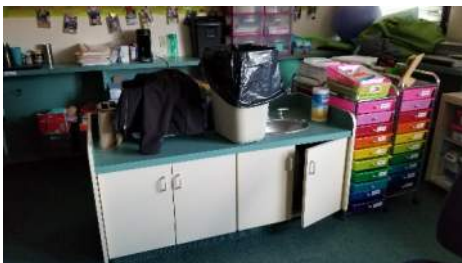
Typical classroom non-compliant sink

CSES.BI.02 Remove existing sink fixtures and associated casework at all classroom locations. Replace with ADA compliant sink with appropriate clearance.

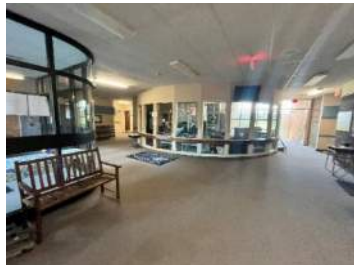
The main entrance is visible from the main office but is not connected. A connected vestibule/main office is recommended for enhanced security.

Disconnected administration offices

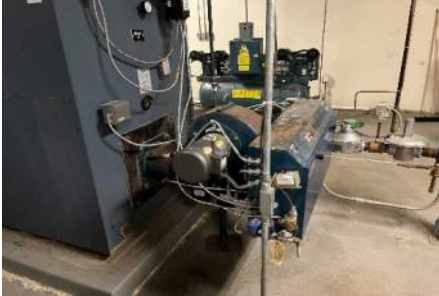
Building hot water is generated by two natural gas-fired Weil Mclain, Model 88, 4,763 MBH cast-iron boilers with Power Flame model WCR3-GO-25B Burners. The breeching and circulator pumps associated with the boilers are in poor condition and portions of the breeching appear to have been installed prior to 1998. The hot water piping and accessories appear to be in fair condition. The chemical treatment system is in poor condition. The boilers have exceeded their expected

Existing Weil Mclain cast-iron dual fuel boiler with Power Flame burner

service lives but no performance issues have been reported by the District.

CSES.HVAC.02 If a building-wide upgrade is not planned, at minimum the existing boilers, breeching, pumps, and hot water accessories should be replaced as they have exceeded their expected life-cycle. In addition, existing rooftop heating and ventilating units should be replaced. If air-conditioning is not anticipated for the school the existing unit ventilator system is adequate within the classrooms.

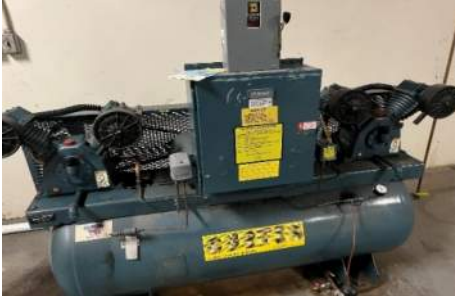
Existing air compressor serving pneumatic control systems

systems throughout the building. An air compressor exists to control portions of the building that are still pneumatic and have not been converted to DDC. The air compressor appears to be in fair condition but should be abandoned as the remainder of the components are converted to a modern control system.

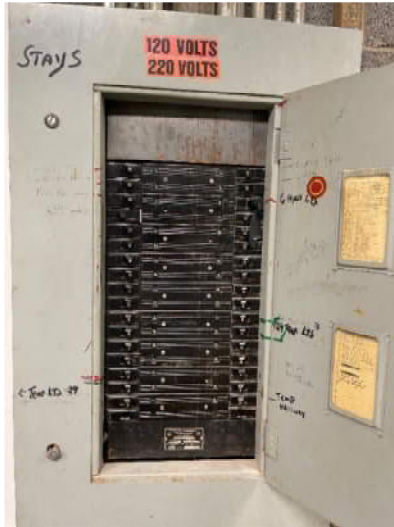
The electrical service drops underground to indoor Non-PCB pot-type transformers located inside a transformer room. The service utilizes bus duct to continue into the main electrical room into an old Westinghouse Main breaker section that is believed to be being used as a junction box. The main electrical gear lineup consists of the old Westinghouse junction box into a Siemens 1000A 208/120V main breaker section/distribution

Old Westinghouse panelboard

section and a 208/120V distribution section dated 1998. The distribution equipment was observed to be manufactured by Square D, Westinghouse, and Siemens. It is recommended that some of the older equipment manufactured by Westinghouse be replaced with new.

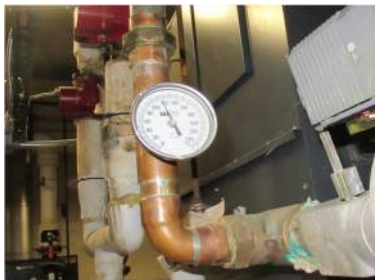
The existing domestic water heating system serving the building includes a 600 MBH gas fired Laars Teledyne hot water boiler with storage tank. The tags on the water heaters indicated they were installed in 2007. The unit appeared to be in fair condition but had signs of leaking joints on associated piping and has reached the expected 15-year service life for the heater. The hot water system includes hot water recirculation, master mixing valve, and expansion tank.

Existing Domestic Water Heater and Observed Corrosion

CSES.P.01 The central domestic water heater is at the end of its expected useful life and corroded fittings were observed on interconnecting piping. The water heater should be replaced as soon as possible. Lack of a duplex water heater installation would cause a complete loss of hot water in the event of a failure.

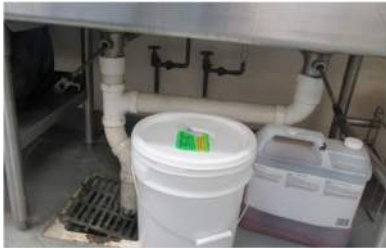
Existing Dishwash Sink without Indirect Drain Connection and Corroded Floor Sink

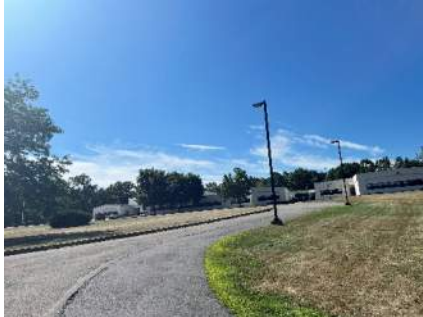
Cracks in drive to main lot

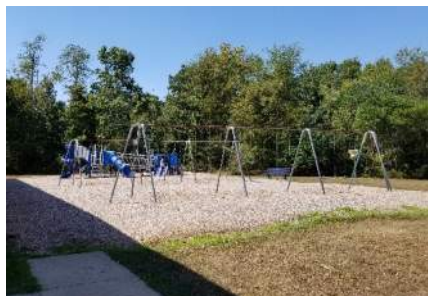
Unsecured play area

NRES.S.05 Fence play area at the west of the building to create a perimeter for safer play.

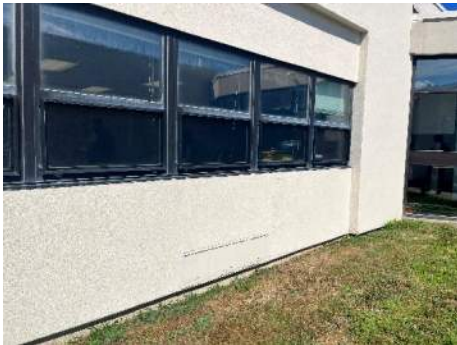
Plaster façade finish

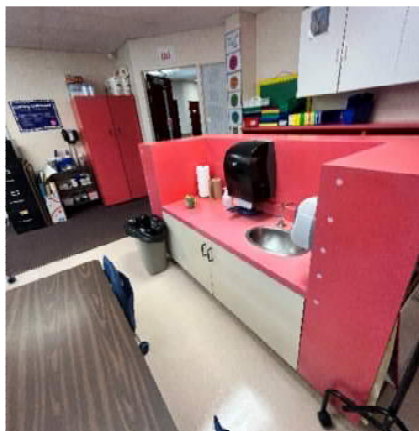
Typical sink in classroom

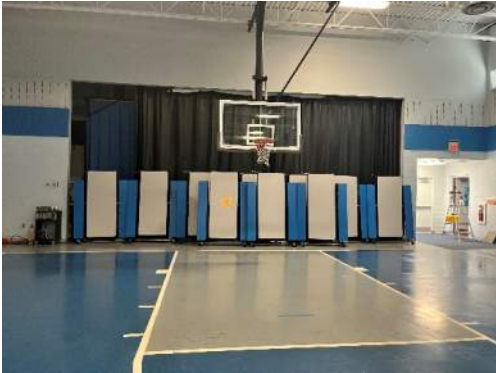
Multi-purpose room with stage.

The multi-purpose room functions as a cafeteria, gym, and auditorium. The kitchen and storage is adjacent with direct access into the space. The stage is a folding stage system, which is a packable stage with risers built in.

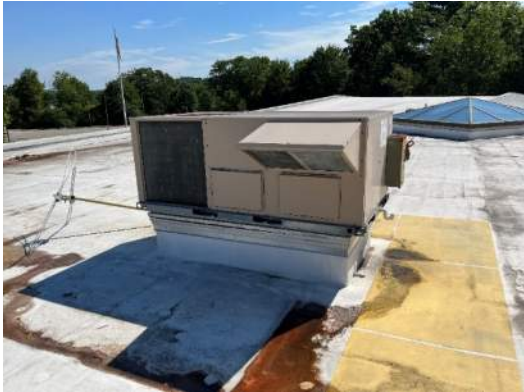
Existing packaged rooftop unit

The Library, Nurse Suite, Administration, and the Open Pod area are each served through a ducted system associated with a rooftop heat pump or air conditioning system. The units are operable, but they are original to the building, have exceeded their expected services lives, and should be replaced.

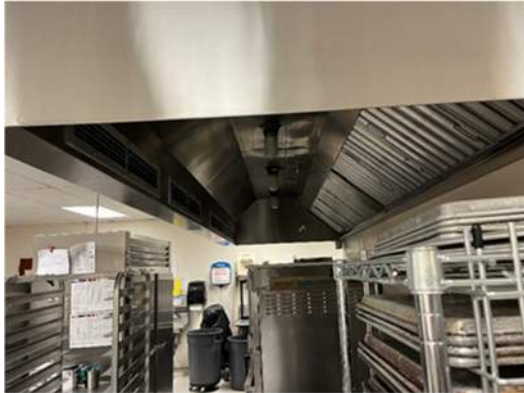
Existing grease hood

The Kitchen exhaust hood is connected to an upblast grease fan located on the roof. An Ansul system was observed within portions of the hood to protect certain equipment types as required by code. A dedicated exhaust fan serves the dishwasher condensate hood. The fans and grease hood appear to be in fair condition.

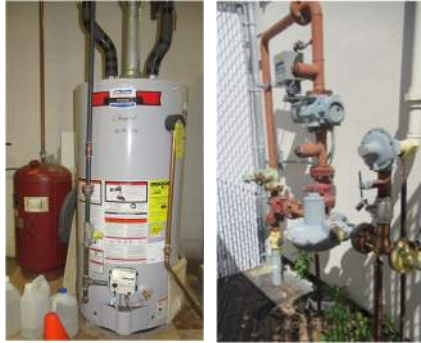
Existing Domestic Water Heater and Gas Service

The existing domestic water heating system serving the building includes a 40 MBH gas fired American Water Heaters storage type water heater. The labelling on the water heaters indicated it was installed in 2020 and it is new condition. The hot water system includes hot water recirculation, two master mixing valves installed in parallel, and expansion tank.

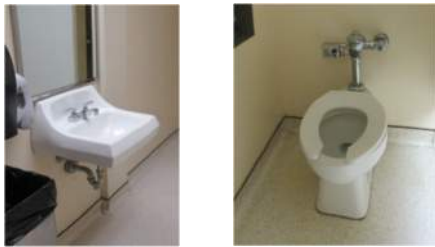
Existing Gang Toilet Plumbing Fixtures

Plumbing fixtures within Gang Toilet rooms include floor mounted water closets and wall hung urinals with sensor operated flush valves, and wall hung lavatories with manual faucets or floor mounted multi-station lavatory systems with mechanically metered faucets. In general, most fixtures are in good condition. These toilet room installations do not comply with all current ADA/ANSI A117.1 accessibility requirements. Lavatories have not been provided with thermostatic tempering valves required by current plumbing code.

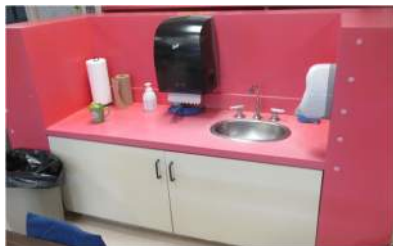
Existing Non-ADA Classroom Toilet Rooms

Plumbing fixtures within the individual Kindergarten classroom toilet rooms include floor mounted “Baby Bowl” water closets and wall hung lavatories installed at Juvenile heights. The fixtures are generally in good condition but the installations do not comply with all current ADA/ANSI A117.1 accessibility requirements.

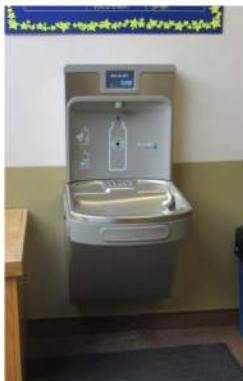
Existing Electric Water Coolers

Most existing Electric Water Coolers are in good condition and have been provided with bottle filling stations; however, they do not comply with ADA/ANSI A117.1 accessibility requirements.

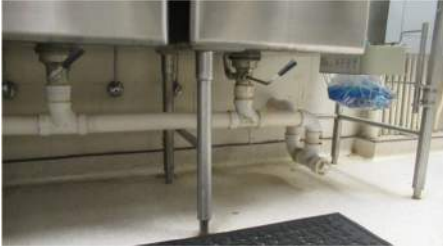
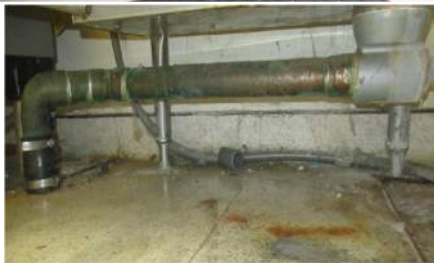
Existing Dishwash Sink without Indirect Drain Connection and Corroded Floor Sink

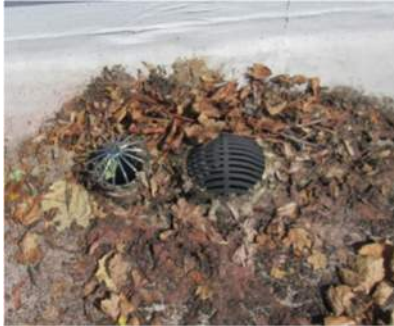
*Existing Roof Drain and
Ponding at Roof Edge*

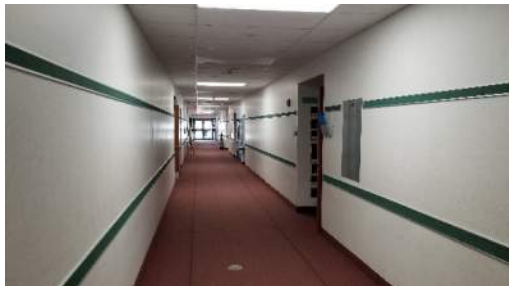
Typical corridor

SAES.BI.05 Replace carpet in corridors with a more durable material like VCT.

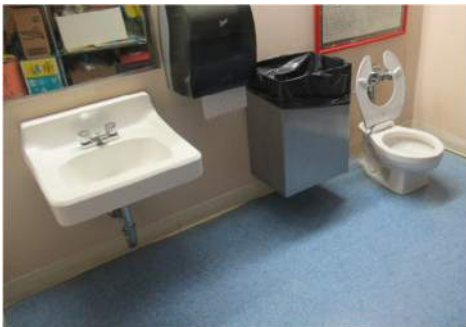
Existing Plumbing Fixtures in Classroom Toilet Rooms

Plumbing fixtures within the individual Kindergarten classroom toilet rooms include floor mounted “Baby Bowl” water closets and wall hung lavatories installed at Juvenile heights. The fixtures are generally in fair condition but the installations do not comply with all current ADA/ANSI A117.1 accessibility requirements.

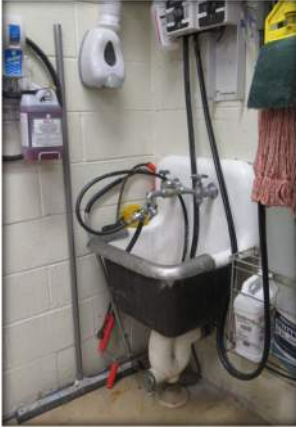
Existing Janitor Service Sink

Existing janitor service sinks are wall hung and not easily used for emptying buckets or other Janitorial functions, and the utility faucets are in poor condition. Auxiliary hose connections have not been provided for connections to cleaning solution dispensers.

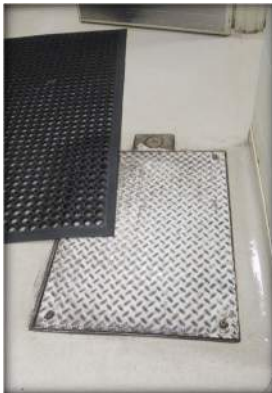
Existing Grease Trap

Kitchen area drainage has been provided with individual steel grease traps recessed within the floor of the adjacent storage room. No condition issues were reported by the school district and the school district confirmed the grease traps are emptied and maintained regularly.

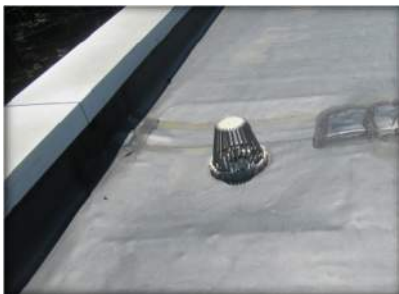
The existing roof is composed primarily of flat EPDM roof construction with gravel stop and/or low parapet edging. The roof drains appeared to be in good condition and free of debris. Emergency overflow scuppers have been provided in lieu of internally piped emergency roof drains.

Existing Roof Drain

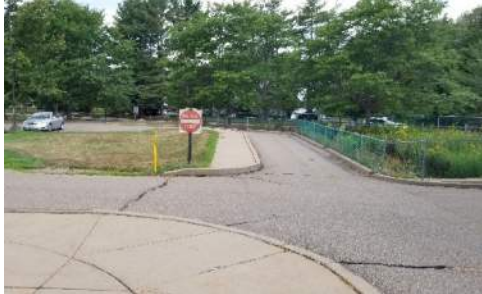
Cracking on driveways

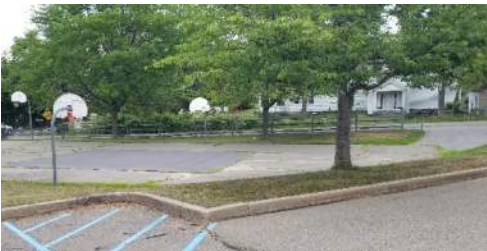
Hard play with cracking/large patches

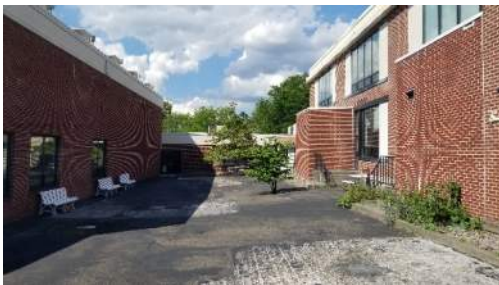
Paving damage at courtyard

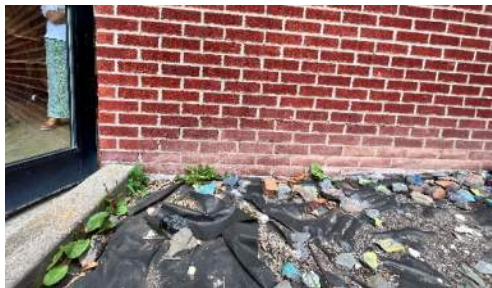
Some cracked mortar and brick staining at courtyard

The façade is primarily comprised of red brick with accents of white cement board. Most of the brick is in good condition, with some staining or efflorescence in select areas. The efflorescence is primarily occurring at the 1994 addition parts of the building.

In the original part of the building, there is some staining and damage at heads and sills of windows and infilled windows.

WES.BX.01 Repair any areas where openings in brick have allowed for efflorescence to occur. Clean off efflorescence.

WES.BX.02 Repair cracks in mortar.

WES.BX.03 Repair or repaint heads and sills of windows.

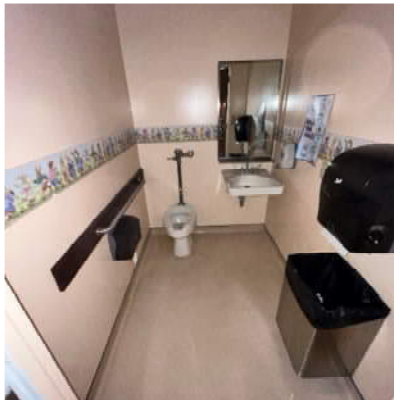
The gang bathrooms in the original building do not provide proper clearances to or within the restroom. These would need to be reconfigured to meet ADA requirements.

Non-ADA compliant toilet room

- WES.BI.01 Install ADA compliant fixtures (handrails, trash receptacles, etc.) in single-use toilet rooms that have compliant clearances.
- WES.BI.02 Reconfigure classroom entrances (3) to meet ADA clearance requirements.
- WES.BI.03 Reconfigure gang toilet rooms on main level and second level.
- WES.BI.04 Replace all sinks in classrooms to provide ADA compliance.

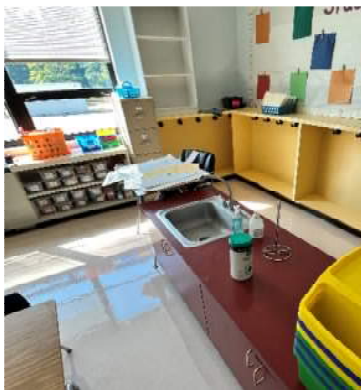
The sinks within the classrooms do not meet the height or clearance requirements for ADA compliance.

Typical sink in classroom

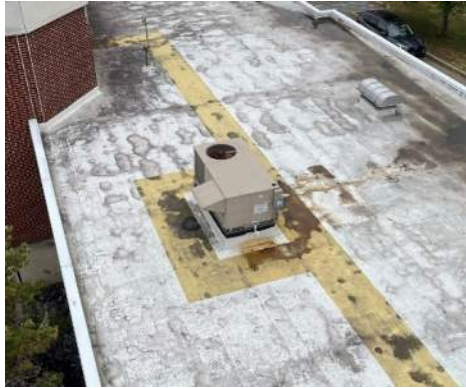
Existing administration rooftop unit

The administration area is served by a packaged rooftop unit that was installed in 1996. The unit consists of mixing box, DX cooling coil, gas furnaces, and a supply fan. The unit is in fair condition. Fan coils (installed in 1996) are present and serving exterior zones. The nurse area is served by a packaged rooftop unit that was installed in 1996. The unit consists of mixing box, DX cooling coil, gas furnaces, and a supply fan. The unit is in fair condition. Exhaust systems in the nurse area appeared adequate for the use of the space.

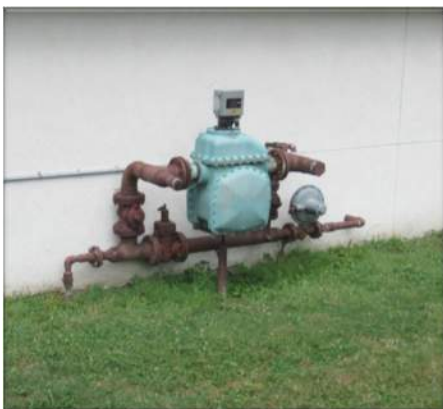
The school has been provided with natural gas service supplied by UGI. A single service has been provided to serve building heating, domestic water heating, and kitchen equipment. The existing meter is an older style, large diaphragm meter and has not been provided with any security enclosure.

Existing Natural Gas Service/Meter

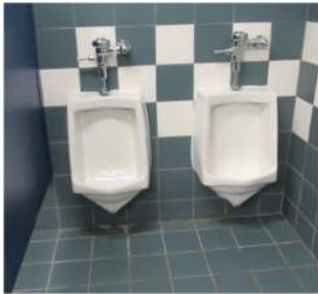
Plumbing fixtures within student gang toilet rooms include floor mounted water closets and wall hung urinals with manual operated flush valves, and wall hung lavatories with manual faucets. In general, most fixtures are in fair condition but are dated and not water conserving type. These toilet room installations do not comply with all current ADA/ANSI A117.1 accessibility requirements. Lavatories have not been provided with thermostatic tempering valves required by current plumbing code.

Existing Student Gang Toilet Plumbing Fixtures

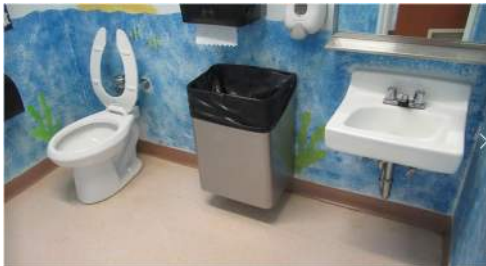
Existing Plumbing Fixtures in Classroom Toilet Rooms

Plumbing fixtures within the individual kindergarten classroom toilet rooms include floor mounted water closets and wall hung lavatories installed at juvenile heights. The fixtures are generally in fair condition but the installations do not comply with all current ADA/ANSI A117.1 accessibility requirements.

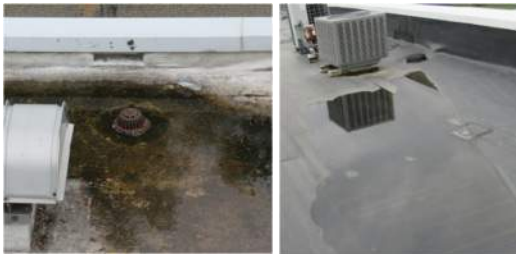
The existing roof is composed primarily of flat EPDM roof construction with gravel stop edging. The roof drains appeared to be in good condition and clear of debris; however, one drain appeared to be blocked and some ponding was observed near roof edges. Emergency overflow scuppers have been provided in lieu of internally piped emergency roof drains.

Existing Roof Drain

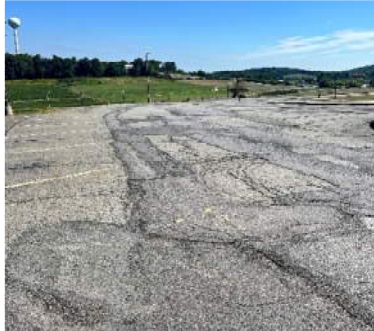
Deteriorating asphalt paving at parking and drives

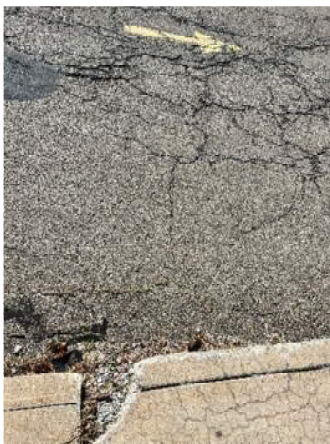
Damaged sidewalk/curb with exposed rebar; asphalt cracking at drive

AHMS.S.02 Replace all sidewalks/ramps at pod exit areas.

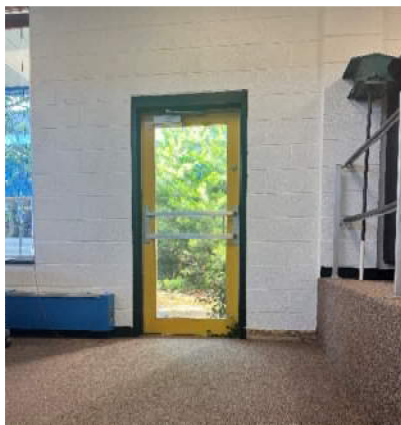
mulched beds. There are multiple points of access into the courtyard, but it is underused and overgrown. There is vegetation growing underneath the doors and is now inside the building.

Courtyard vegetation at the library door

AHMS.S.06 Clean up courtyard overgrowth.

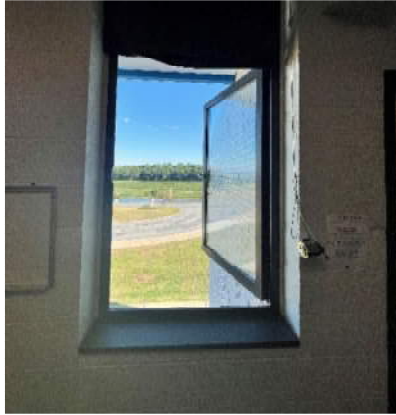
Full-swing operable window

AHMS.BX.03 Add stops to all operable windows so the opening will not allow a 4" sphere to pass through when fully extended in open position.

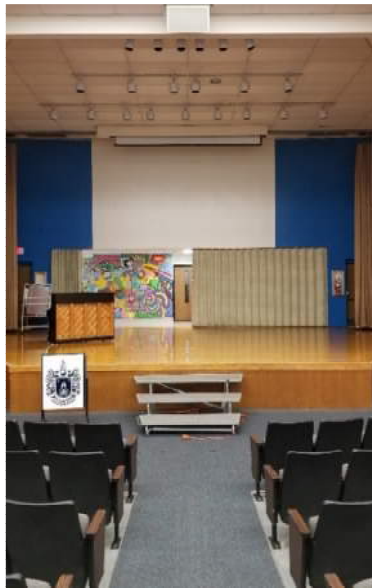
The auditorium is divided into small sections with the use of folding partitions. Some of the partitions do not function properly and have issues opening and closing.

Auditorium (center room)

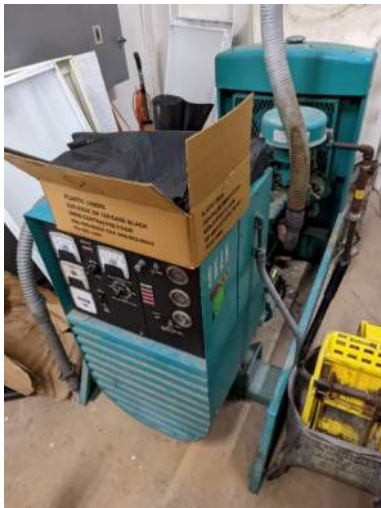
There is a 30kW 277/.480V interior natural gas generator manufactured by Onan located inside the main electrical room. The generator is original to the building and services a single ASCO transfer switch, also original to the building. There does not appear to be separation between life-safety and non-legally required loads, however, the majority of the load is normal emergency lighting. To be code compliant the life safety and equipment (non-legally required) branches cannot share the same panel and needs to be physically separated. This generator is at the end of its life. It appears that the generator does not backup any network, paging, or intercom systems.

Engine Generator

Currently the generator and transfer switches and other associated emergency electrical equipment are all located in the same room as the normal power electrical equipment. This is not permitted by code. National Fire Protection Association (NFPA) 110 code states that the EPSS (transfer

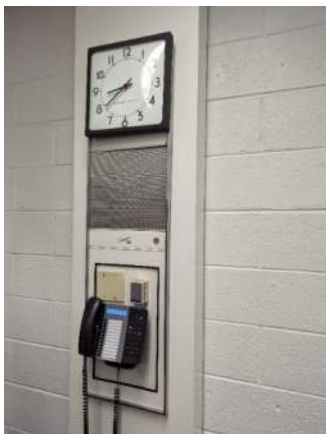
The original Simplex PA/Clock system with wall mounted speakers and clock assemblies are located throughout the building. Some clocks have been replaced with American Time clocks. The existing intercom system appears to be in adequate condition but dated and at the end of its serviceable life. The existing phone system is a Mitel Voice Over IP (VOIP) and appears to be in adequate condition.

Existing clock/speaker assembly

It is recommended that the existing public address system be upgraded to an I.P. intercom system. PA system will be approaching end of life soon and should be replaced in 3-5 years.

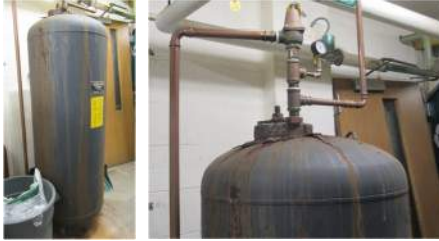
Existing Domestic Water Heater Expansion Tank and Observed Leak

expansion tank had visible leakage and corrosion at the access way for the diaphragm. The system includes a recirculation pump/system but no master mixing valve was observed at the heater system.

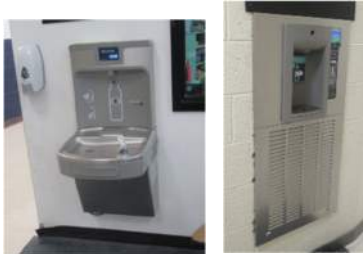
Existing Electric Water Coolers

Most existing Electric Water Coolers are in good or fair condition and fitted with bottle fillers; however, they do not comply with ADA/ANSI A117.1 accessibility requirements.

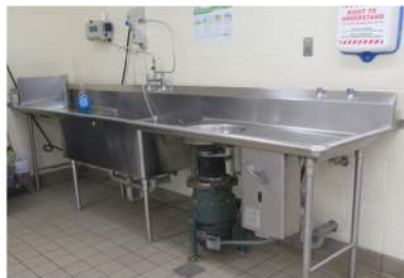
Several kitchen food prep sinks and the dishwashing sinks have been installed without code required indirect drainage to prevent backup of sanitary drainage into food prep bowls. Drainage piping in several sinks is also installed without the code required venting which could lead to siphoning of the traps.

Existing Food Prep and Dishwash Sink without Indirect Drain Connection

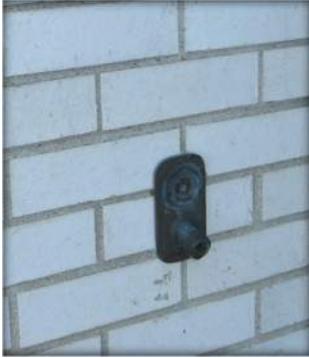
Existing exterior non-freeze wall hydrants lack lockable cover to prevent tampering.

Existing Non-Freeze Wall Hydrant

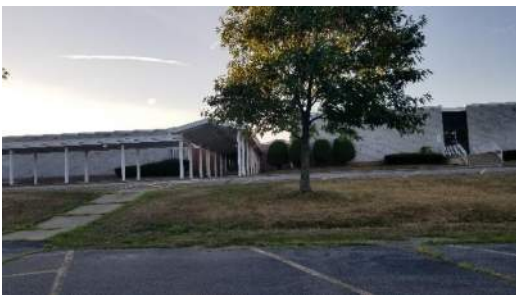
Cracked paving at front entry; steep sloping sidewalk with no handrails; vegetation growth between sidewalk joints

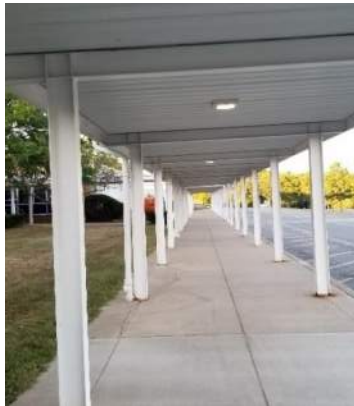
Surface cracking at main entry sidewalk

There is a sidewalk that wraps around the west, south, and east sides of the building. The sidewalks are mostly in fair condition, with just some wear on edges or surface cracking.

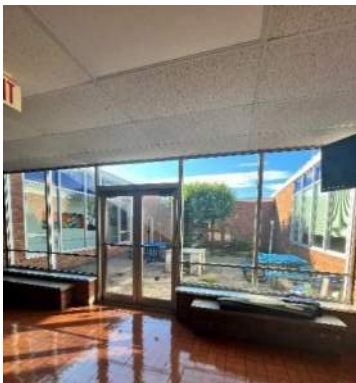
Courtyard at front entry

There are two courtyards within the school building. Both are concrete paving with garden beds throughout. Both courtyards have significant cracking in pavement and the concrete benches. The vegetation is overgrown and unkept. The courtyards are not ADA accessible since they are about 6" lower than the finished floor level access point.

AHHS.S.04 Repair or remove built-in benches.

AHHS.S.05 Clean up courtyard overgrowth and repair garden beds (block walls).

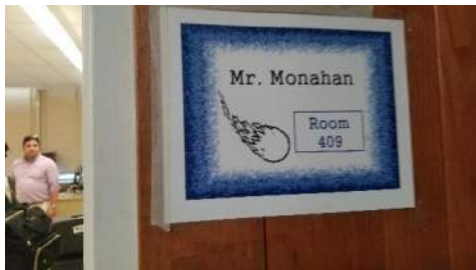
Non-compliant room signage

AHHS.BI.01 Replace all room signage throughout.

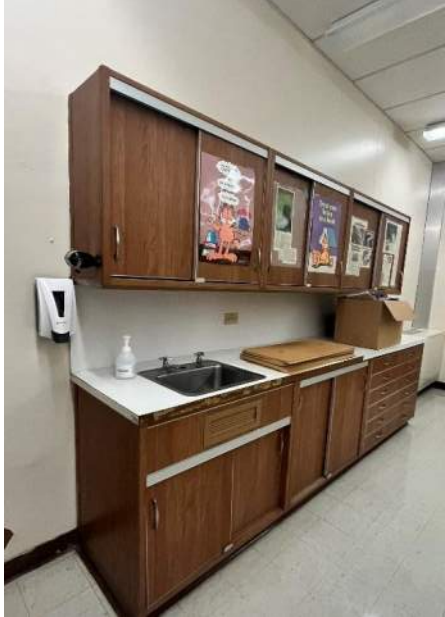
Non-compliant classroom sink fixture

The sinks in casework throughout the building (mostly located in science classrooms) do not meet the height or clearance requirements for ADA compliance.

AHHS.BI.03 Replace sinks and associated casework in rooms so that all rooms with sinks have at least (1) ADA accessible fixture.

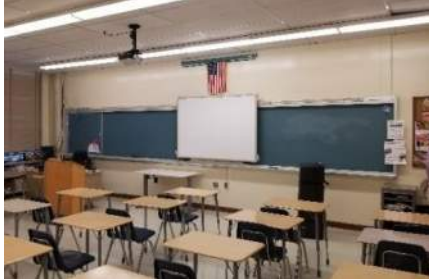
Typical classroom in original part of building

Classrooms in the older part of the academic wing have damaged casework and chalkboards which are in need of replacement. Classrooms in these wings have VCT flooring and ACT ceilings.

AHHS.BI.05 Replace casework and chalkboard in original part of building to accommodate new technology/teaching surfaces.

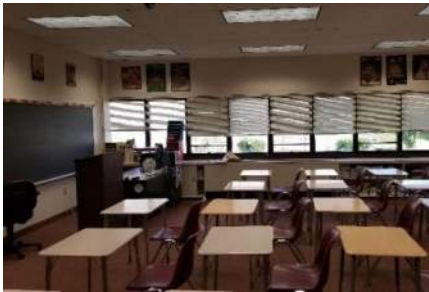
Typical classroom in 1995 addition

The 1995 addition has carpet flooring and ACT ceiling throughout. The carpet is in poor condition. The entrances are not ADA compliant, as mentioned above.

AHHS.BI.06 Replace carpet with a more durable surface like VCT in 1995 wing (both floors).

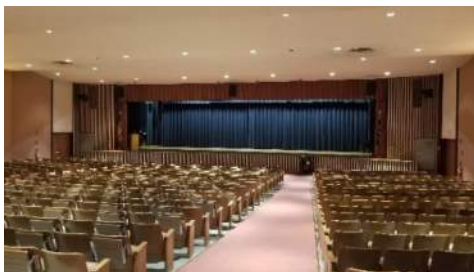
Auditorium

The auditorium has seating with carpeted aisles and exposed concrete under the seats. The ceiling is gypsum board with recessed lights. The seats, carpeting, and painted concrete floor are in poor condition. There are no areas for ADA compliant seating.

AHHS.BI.08 Replace carpet and seats within auditorium.

AHHS.BI.09 Create ADA seating areas.

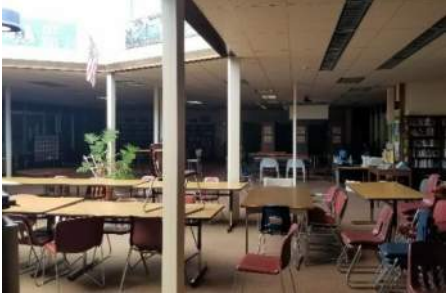
Library

The library is located in the center of the school. There is a skylight that allows natural light into the space. While the space is large, it is underutilized and outdated. The flooring is carpet and the ceiling is ACT. The carpet is in poor condition.

AHHS.BI.10 Renovate library for a more flexible, STEM driven environment. Replace carpet with a more durable material like VCT.

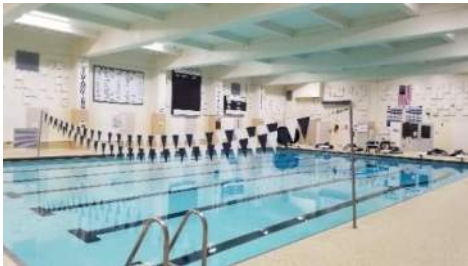
Pool

The pool and finishes are in fair condition. There is built-in bleacher seating which does not provide ADA compliant access.

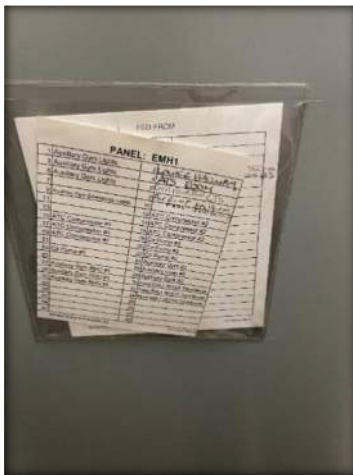
Equipment panelboard with life safety circuits

Current codes call for selective coordination on the life safety portion of the emergency generator. There appears to be selective coordination issues with the life safety distribution due to the main output breaker in the generator being rated at 60A.

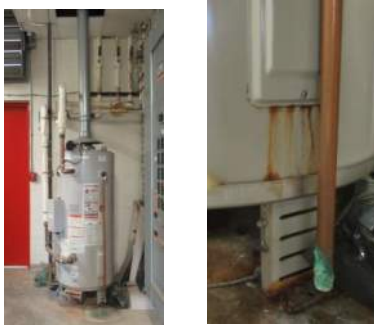
Existing Domestic Water Heater and Observed Leak

Interconnecting piping is missing insulation in several locations and is heavily corroded. Recirculation pump and thermostatic master mixing valves were observed and appear to be in fair condition.

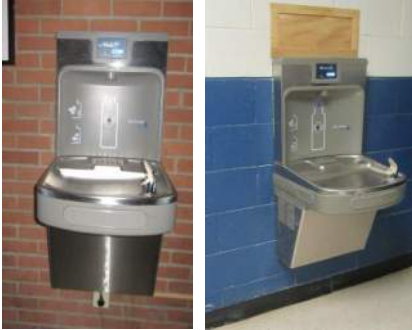
Existing Electric Water Coolers

Electric water coolers with bottle filling stations have been retrofitted in some area but most installations do not comply with current ADA/ANSI A117.1 accessibility requirements.

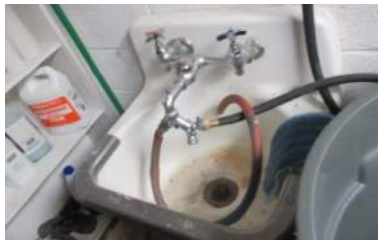
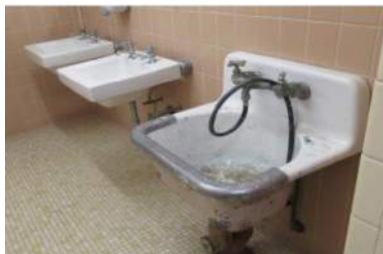
Existing Janitor Service Sinks

Existing janitor service sinks are wall hung and not easily used for emptying buckets or other Janitorial functions, and the utility faucets are in poor condition. Auxiliary hose connections have not been provided for connections to cleaning solution dispensers. Several janitorial sinks are located within gang toilet areas and not within dedicated janitorial closets.

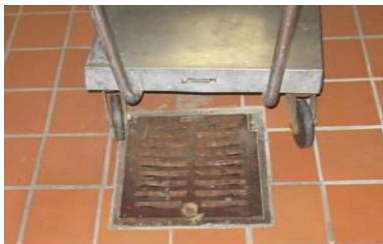
Several kitchen food prep sinks and the dishwasher have been installed without code required indirect drainage to prevent backup of sanitary drainage into food prep bowls. Drainage piping in several sinks is also installed without the code required venting which could lead to siphoning of the traps. Existing epoxy coated floor sinks have begun to chip and corrode which is a less sanitary installation and could be cited by local DOH inspectors.

Food Prep Sink without Indirect Drain Connection and Corroded Floor Sink
